TEST REPORT

LLumar® SCL SR MPS8 Multi-Ply Security Film Tested In Combination With FrameGard Gullwing Flexible Anchoring System

Explosion Range Testing ComBlast 2005

Document prepared by: Simon Trundle
Trials Manager
ComBlast 2005
Test Report Ref: GDA/71-1788s
Date: 20/12/2005

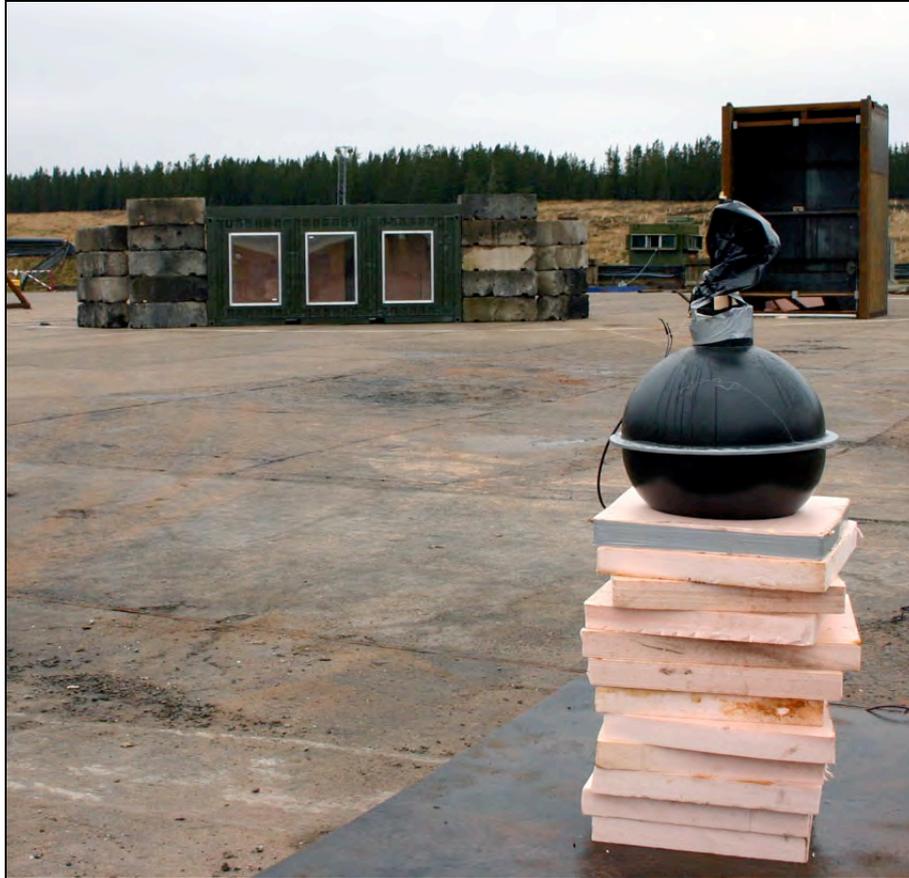
P1: Explosive charge and test arena

The nitro-methane charge size used in these tests was selected as a direct equivalent to 100kg TNT high explosives and the equivalency was proven in extensive UK government sponsored testing. The explosive charge was supported on polystyrene packing to ensure that no fragments would be ejected from the steel plate used as the charge support.

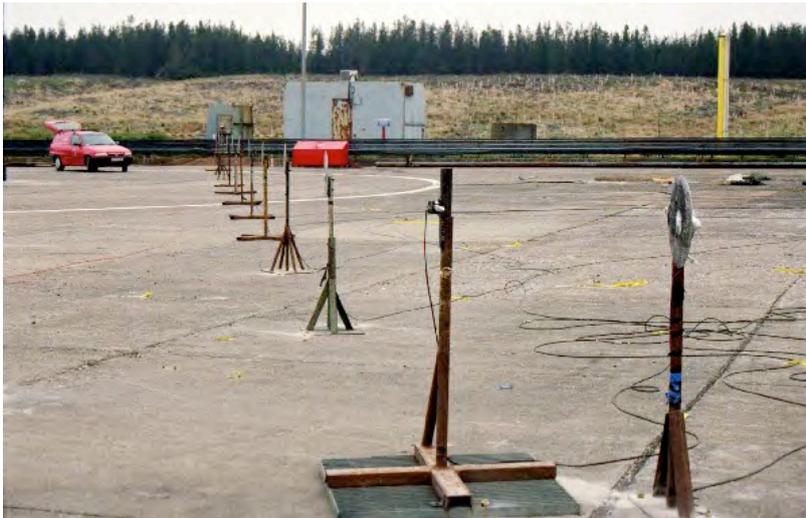
**P2: Free field gauges**

Photos show free field gauges [P2] for measuring side-on incident pressure and the gauge block [P3] used for measuring reflected pressure on the face of test specimen.

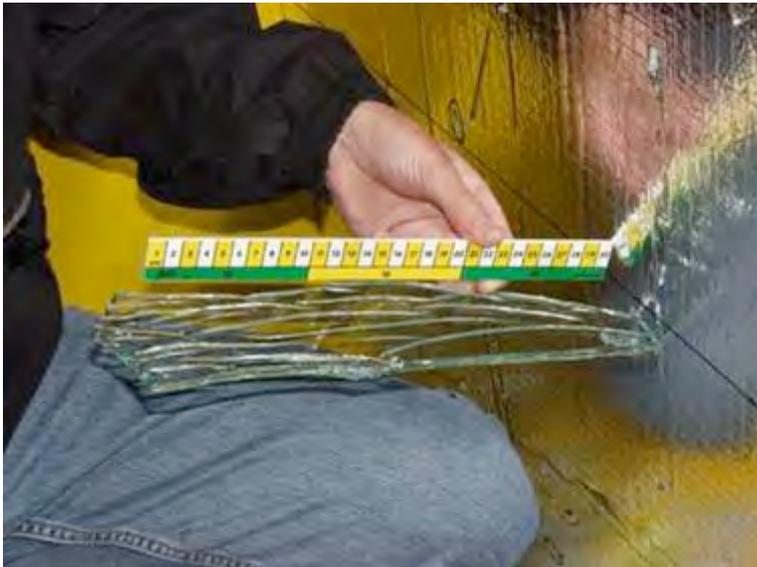
In a previous test on un-filmed annealed float glass at 33 metres from 100kg TNT the glass was driven to the rear of the test cubicle striking and impacting into the witness board as indicated in the photograph below.

P4: Fragments of untreated glass measuring more than 300mm in length embedded into the rear witness panel.

This photograph is reproduced in this report to provide a benchmark for performance of annealed float glass at 33 metres range from 100kg and thus allow comparison of the CPFilms and FrameGard products under similar test conditions.

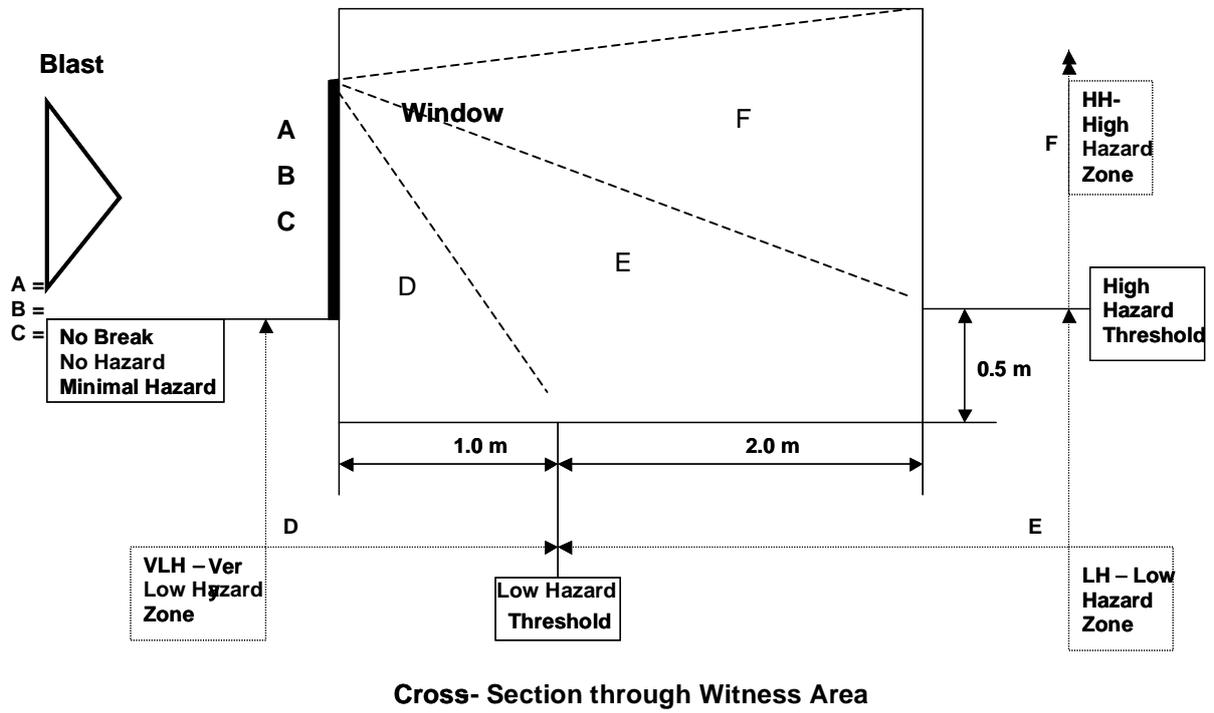
Figure 1: ISO/DIS 16933 standard hazard zones.

The results of the test classification are expressed in the following graphic

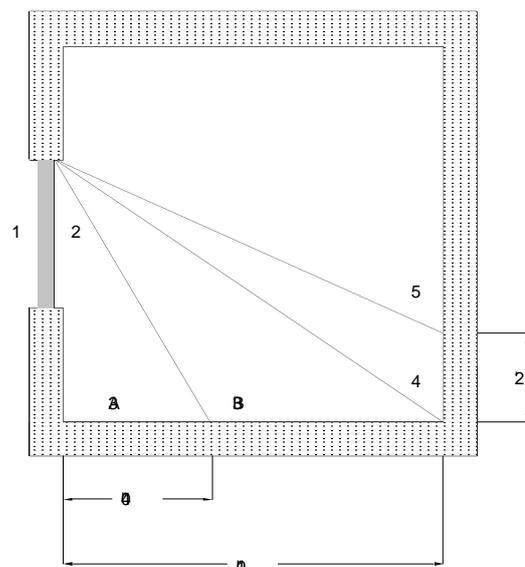
Figure 3: US GSA Performance Zones

Note that the High Hazard rating 5 equates to high risk of fatal injury to occupants

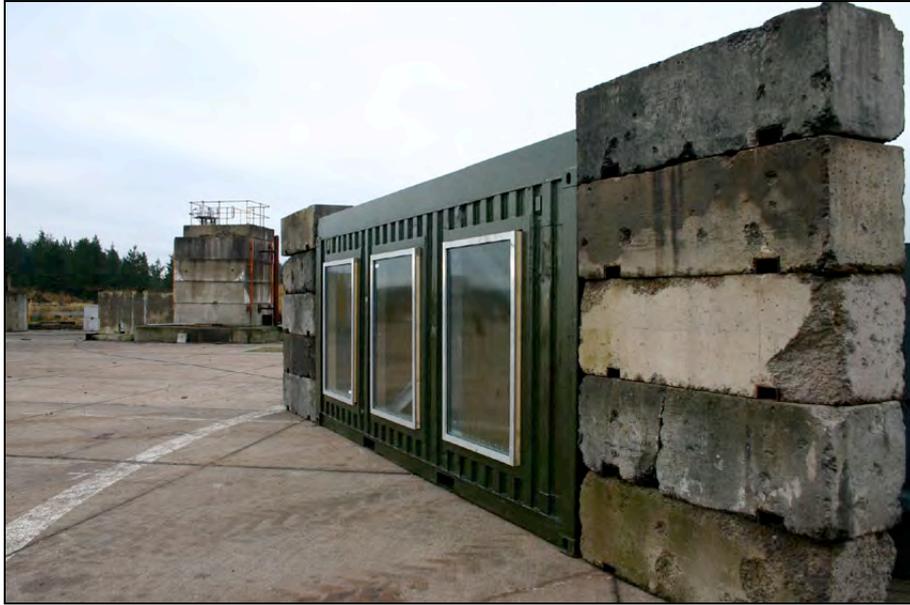
P5: View of test structure prior to detonation

Window test specimens were mounted into a steel test structure with reinforced concrete walls at either side to increase the front face area to 9m x 3.0m overall.

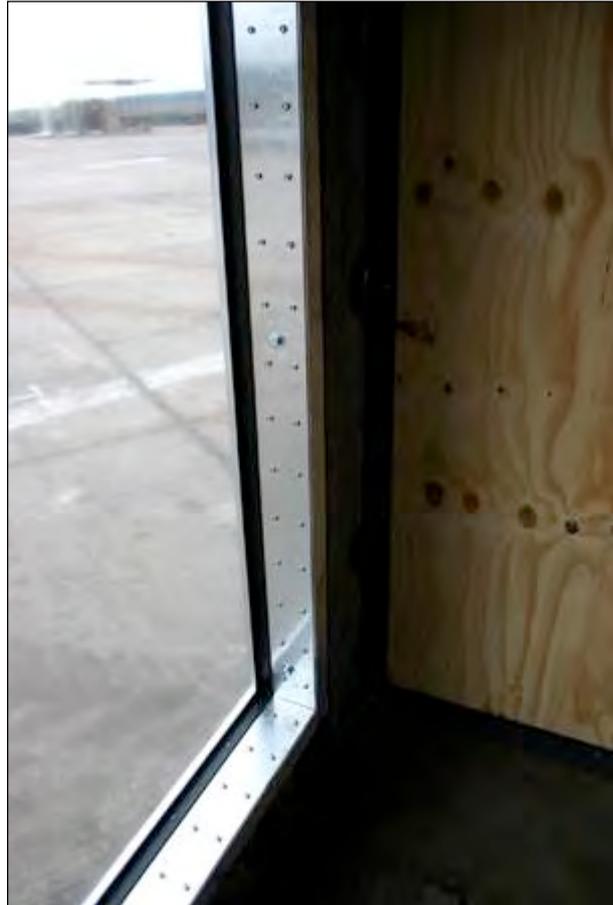
P6: Mounting Of Samples

Photo shows detail of typical window test frame. The screws visible in the photo were used to attach a snap-on plate section within the aluminium profile to ensure that the plate did not become detached in the blast and impact upon the results.

A total of 6 number M10 high tensile bolts were used to fix the window frame into the test cubicle opening. The rigidity of the fixing method adopted in the trials ensures that all of the blast energy is transmitted to the window filmed lite rather than absorbed through deformation of the window frame.

The black section around the perimeter of the glass is the FrameGard Gullwing flexible anchoring system.

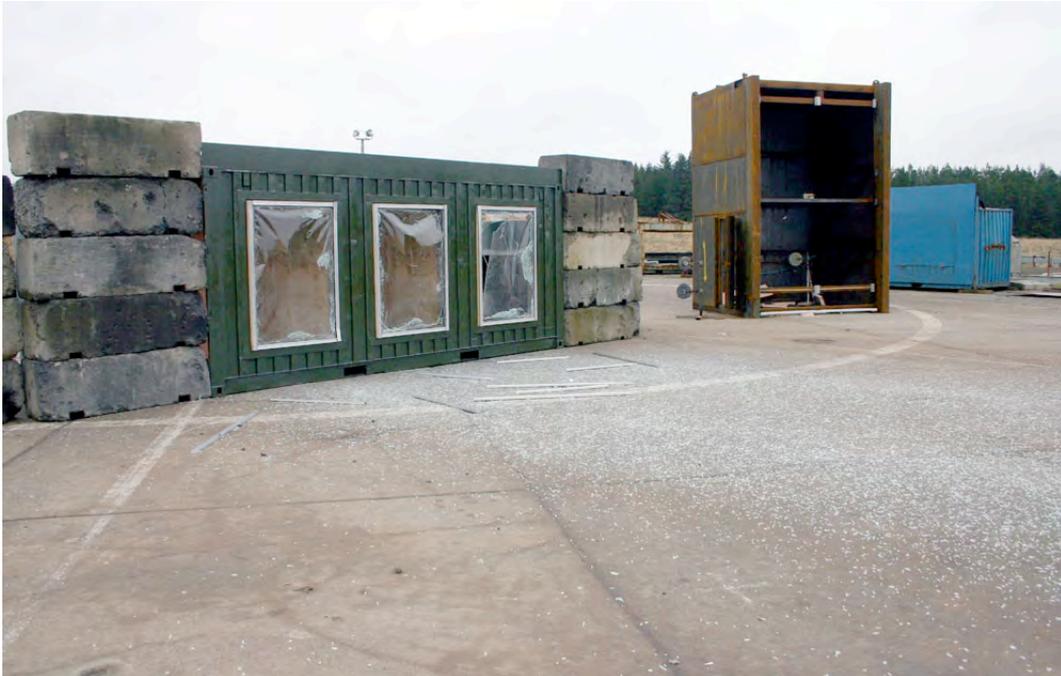
P7: View of test cubicle post detonation of 100kg TNT at 31metres stand off.

The three test specimens suffered loss of glass off the film in the negative rebound energy phase of the blast [also called suction phase] and the glass was deposited to the front of the test cubicle with fragments extending as far as 22 metres from the window opening.

Reviewing the high speed video record of the test showed that the CPFilms LLumar® SCL SR MPS8 security window film in combination with the FrameGard Gullwing flexible anchoring system survived the positive pressure phase of the explosion substantially protecting the interior of the test cubicle before the glass was drawn off the outside face of the film in the negative phase. Small amounts of glass were discovered within the centre and right-hand test cubicles where the film had torn at the perimeter and while passing through several deflection cycles allowing some glass to be cast into the interior of the test cubicle from the torn edge of the film.

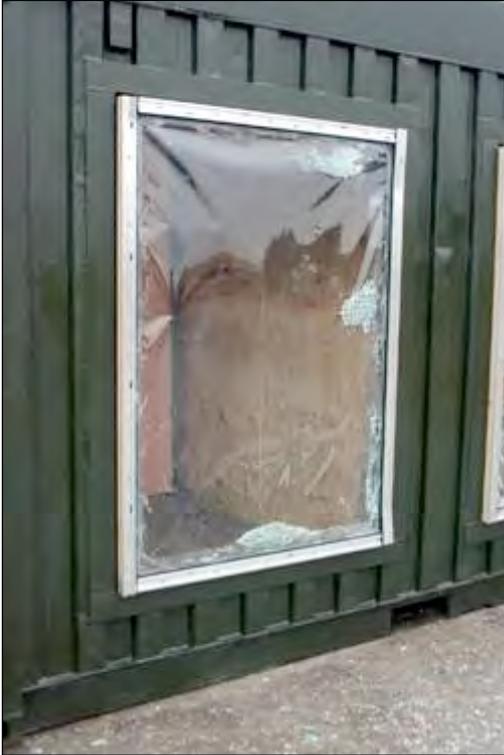
P8: External view of test specimen L1

The test specimen lost approximately 94% of the glass from the outer surface of the film. The FrameGard Gullwing anchoring system became detached along a section of the left hand reveal measuring 380mm in overall length. The detachment of the anchoring profile allowed a small quantity of glass fragments to land inside the test cubicle. The total of the fragments weighed less than 50 grams.

The test specimen was prepared only 10-11 days before the test, allowing a short time for the LLumar® SCL SR MPS8 security film to cure, in order to provide a severe test of film + anchoring system performance. The cold temperatures on the test pad [2°C] added to the reduced curing period will in our opinion account for the loss of adhesion between the film and the glass and could also have contributed to the minor splitting of the anchoring profile.

1. Low Hazard classification in accordance with UK Home Office Scientific Development Board.
2. Classification C Minimal Hazard in accordance with draft ISO/DIS 16933 standard.
3. US GSA classification 2 although it should be noted that this classification was achieved at 8.41 psi pressure loading compared to the 4 psi GSA requirement and similarly 43 psi-msec reflected impulse load compared to 28 psi-msec GSA requirement.

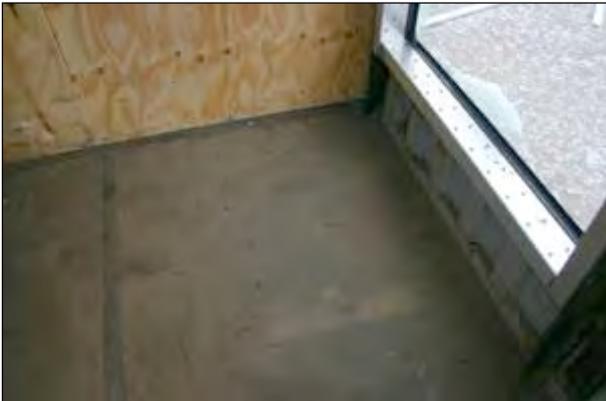
P9: Interior Of Test Cubicle – Left Hand window L1

Glass fragments were discovered on the floor inside the test cubicle totalling less than 50 grams and thought to originate through a small edge tear in the window film. The fragments were all within one metre from the window.

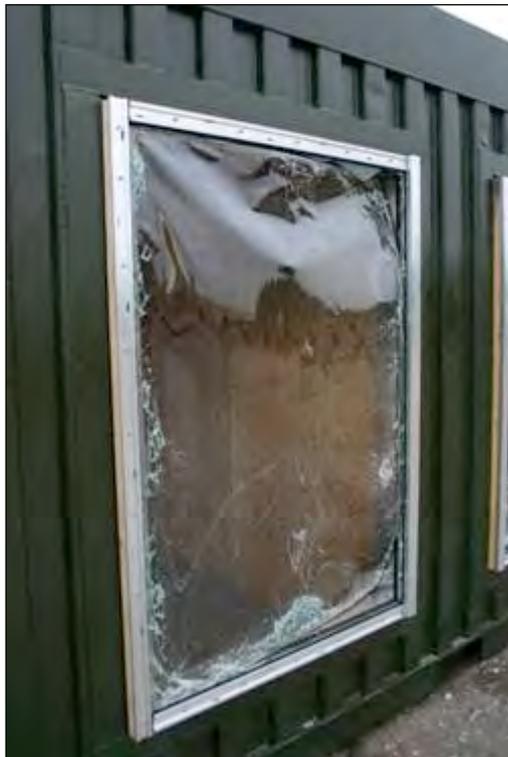
P10: View of test specimen C2 – centre window slot in test cubicle.

The test specimen lost approximately 92% of the glass from the outer surface of the film. The film split along the top right hand [880mm] and bottom right hand [989mm] corners.

Examination of the test video showed the tearing of the window film occurred during the negative suction phase which accounts for the relatively low mass of glass landing inside the test cubicle. The FrameGard Gullwing anchoring system remained attached to the window frame.

The test specimen was prepared only 10-11 days before the test, allowing only a short time for the LLumar® SCL SR MPS8 security film to cure, in order to provide a severe test of film + anchoring system performance. The cold temperatures on the test pad [2°C] added to the reduced curing period will in our opinion account for the loss of adhesion between the film and the glass and could also have contributed to the minor splitting of the anchoring profile.

1. Low Hazard classification in accordance with UK Home Office Scientific Development Branch.
2. Classification D Very Low Hazard in accordance with ISO/DIS 16933 draft standard.
3. US GSA classification 3B although it should be noted that this classification was achieved at 8.52 psi and 45.13 psi-msec which exceeds the 4 psi and 28 psi-msec requirement of the GSA test.

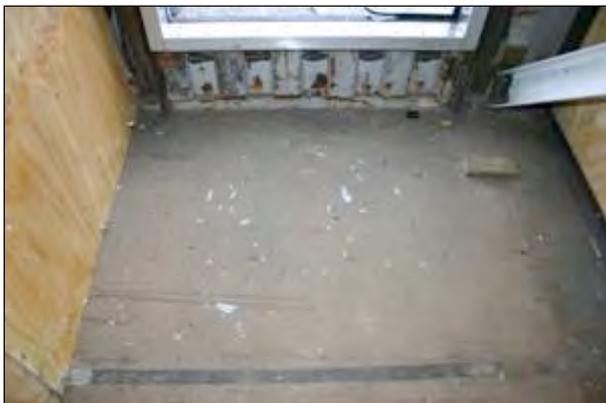
P11: Interior of centre test cubicle

The glass scatter was primarily within the 3A Zone i.e. within one metre of the window sill.

The total glass mass discovered inside the test cubicle was as follows:

196 grams in Zone 3A and 52 grams in Zone 3B.

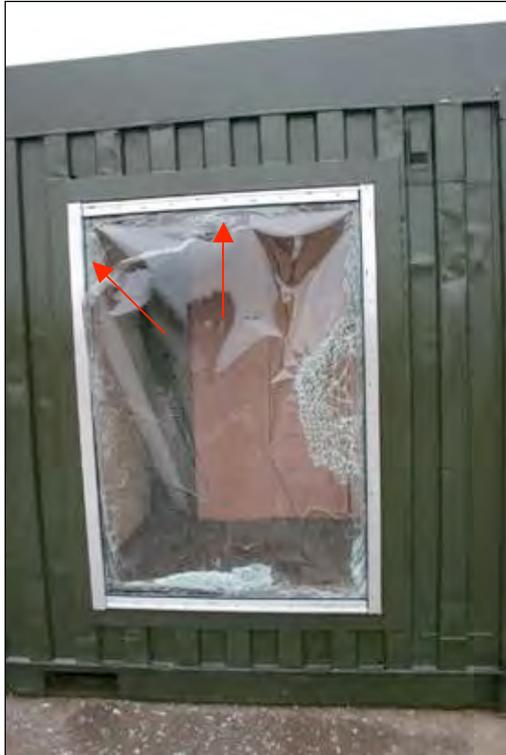
P12: External view of test specimen R3 post test.

The FrameGard Gullwing anchoring system became detached along the left hand edge [in photo] and the window film split diagonally across over a length of 970mm at the position indicated by the arrows.

Examination of the test video showed the tearing of the window film occurred primarily within the negative suction phase with the window film and anchoring thereafter going through several deflection cycles before coming to rest. Glass was ejected into the interior of the test cubicle through the opening made by the splitting of the Gullwing anchoring and the film.

The test specimen was prepared only 10-11 days before the test, allowing only a short time for the LLumar® SCL SR MPS8 security film to cure, in order to provide a severe test of film + anchoring system performance. The cold temperatures on the test pad [2°C] added to the reduced curing period will in our opinion account for the loss of adhesion between the film and the glass and could also have contributed to the minor splitting of the anchoring profile.

1. Low Hazard classification in accordance with UK Home office Scientific Development Branch.
2. Classification D Very Low Hazard in accordance with ISO/DIS 16933 draft standard.
3. US GSA classification 3B although it should be noted that this classification was achieved at 8.52 psi and 45.13 psi-msec which exceeds the 4 psi and 28 psi-msec requirement of the GSA test.

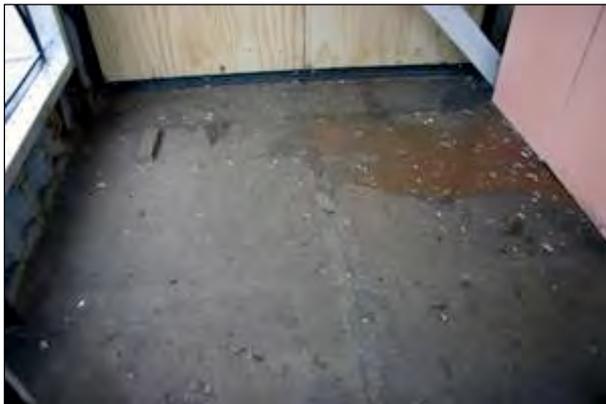
P13: Interior of test cubicle specimen R3.

The glass scatter was spread throughout zones 3A and 3B. The total glass mass discovered inside the test cubicle was as follows:

98 grams in Zone 3A and 166 grams in Zone 3B with 3 small fragments [$< 10\text{g}$] in the witness panel 230mm above the floor level.

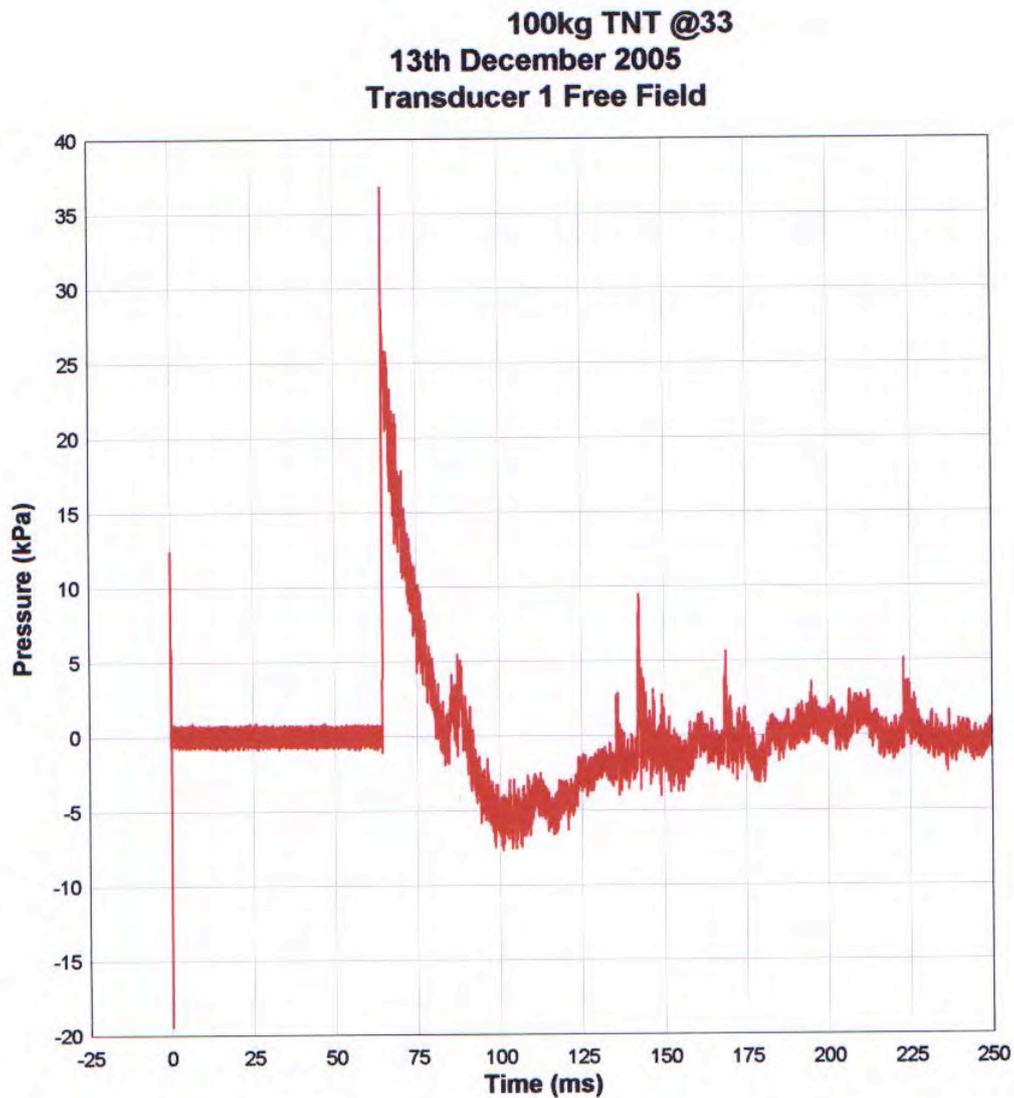
Plot #1: Transducer measurement in free field [side-on] configuration for CPFilms test on 13th December 2005.

The graph indicates a peak side-on pressure of 37kPa; however, interpretation of the graph provides a reading of 26 kPa for side-on pressure after adjusting for 'noise' spike which has minimal energy.

Reflected pressure is predicted as twice the side-on pressure and impulse reading.

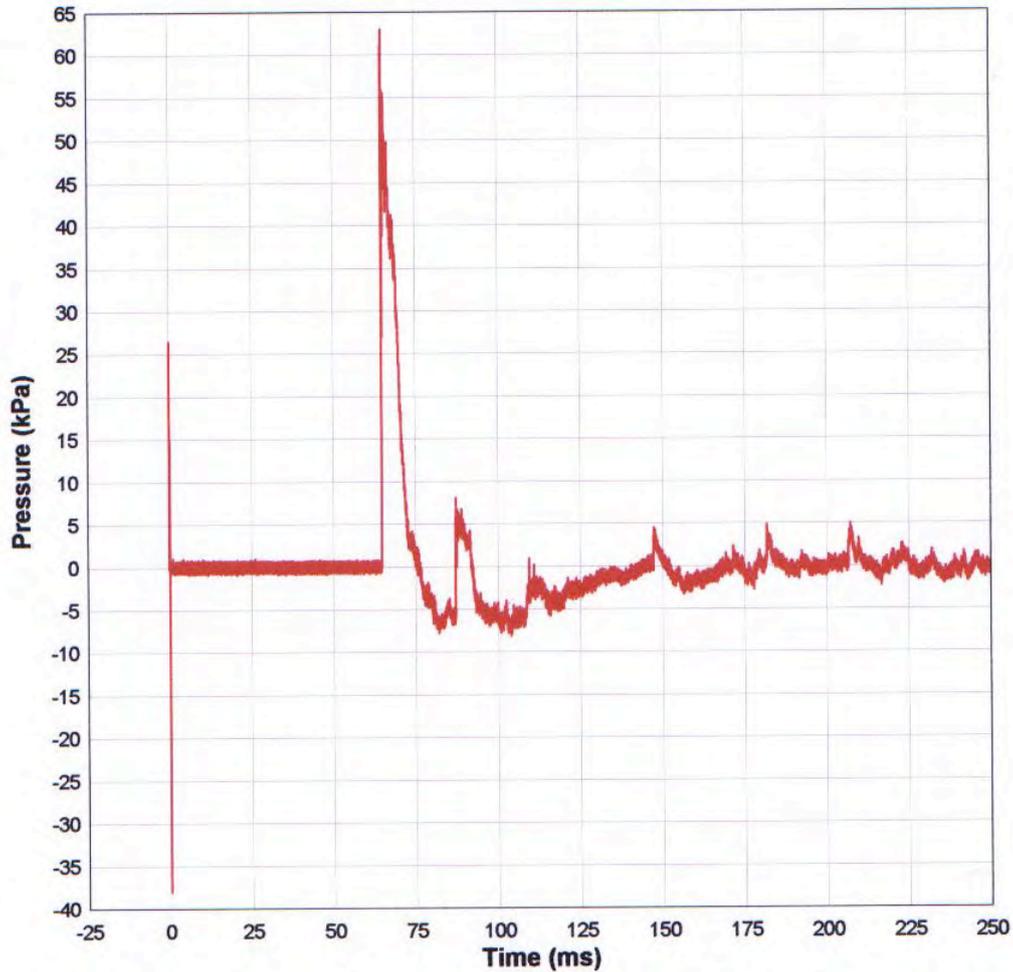
Plot #2: Transducer measurement in reflected gauge block set at 33 metres from charge in CPFilms test on 13th December 2005.

The graph indicates a peak pressure of 63 kPa, however, interpretation of the graph provides a true reading of 57 kPa for reflected pressure and 292 kPa-msec for reflected impulse after adjusting for 'noise' spike which has minimal energy.

100kg TNT charge Shot number and range	Reflected Pressure		Reflected Impulse	
	P _{so} kPa	P _{so} psi	kPa-msec	psi-msec
Shot No 1 @ 33metres	Effective peak of 57 kPa	8.4	292	43

Table 2 includes the values measured over 2 separate gauges set into the face of the reinforced concrete gauge block. In addition, 2 side-on gauges standing in the free field arena measured the side on pressure as the blast wave passed by and the results indicated by the side on readings support the reflected pressure values listed above.
